CHRISTOPHER P. STATILE, P.A.

Memo

Regarding: Block 3103, Lots 16 & 19
Avalonbay Communities, Inc. Site Plan Application Drainage Review

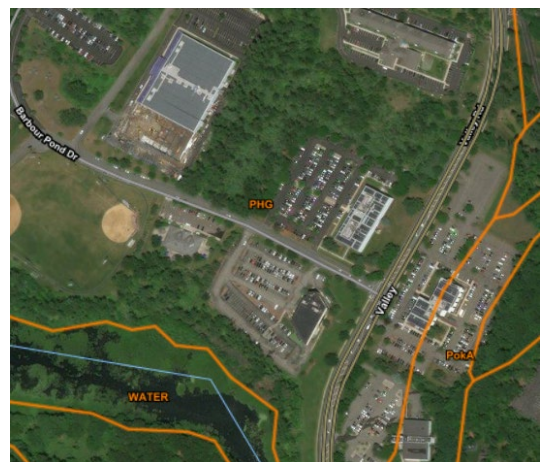
Pits, Sand and Gravel

8. The designer uses the 1975 Passaic County Soils Map to identify the underlying soils designating the area as "Pits, Sand and Gravel" (PHG) with a poor Hydrological Soil Group Designation of "D" rather than using actual soils data from test pits. Group "D" would presume that ongoing soil mining activities are occurring on the site which they are obviously not. The sites were long ago restored and mature trees are found. Soil Maps are to be used only as a starting point/guide in design as their accuracy is very limited and incomplete. The information presented on the USGS 1955 Quad Map (revised 1981) indicates the project area ground surface as being disturbed presumably due to soil mining or development activities, although we have no historic information on

Pits, sand and gravel (Pl), are open excavations from which the soil and an underlying mixture of sand and gravel have been removed. The sides are steep in pits that have been recently excavated. The bottoms of some pits have been cut in steps, but most bottoms are sloping. In places bottoms are below the depth of the water table.

A hazard of ground-water pollution exists in areas that are used for disposal of liquid or solid wastes. Abandoned pits become eyesores if grading, erosion control, and revegetating are not part of the restoration process. The low available water capacity limits the growth of plants. The pits have potential for recreational, industrial, or commercial uses. Not assigned to a capability unit or woodland group.

Therefore actual soils data is required via field test pits taken to at least 5 ft. below the bottom of the sand filters, given the magnitude of development and its reliance on the filters/detention systems. Provisions for groundwater recharge must be provided.
